Case Report

# A Case Report on In Situ Breakage of Etonogestrel Implant- A Rare Occurance

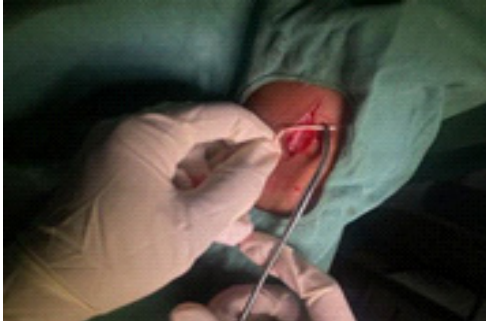
**Figure 3:** Clinical image

insertion of implant patient gave history of ammenorrhoea. Patient had an unremarkable history. Patient had history of lifting heavy bucket while doing household work following which she felt that the device was bent. On examination etonorgestrel implant could be palpated but a central concavity could be felt and there was a breach in continuity of implant. The patient wanted removal of the implant. Following the guidelines by manufacturer the implant was removed (Figures 1 & 2). Prior to removal of implant urine pregnancy test was done which was negative. There was a break in etonorgestrel rod at the distal one- third with a noticeable breach in continuity (Figure 3). Procedure was tolerated well by patient without any complications.
